# Manhole Inspection Summary

Manhole # S33QQ\_035MH

Insp Date: **10/23/07 11:07 AM**

**Location** Address: **138 25TH ST**

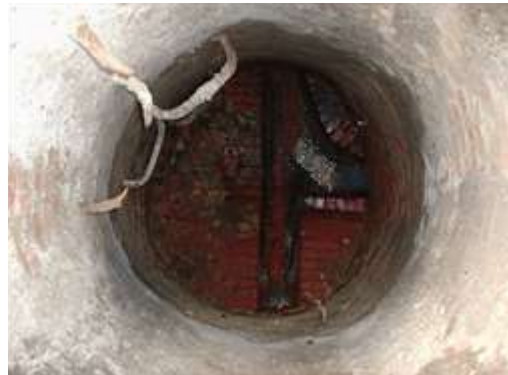
Top View

Corroded and missing steps. Evidence of surcharge - Bench debris.

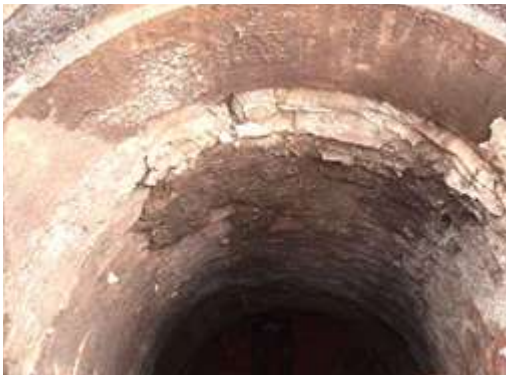
Defect

Frame leaks. Cracked frame. Adjustment infiltration. Barrel infiltration.

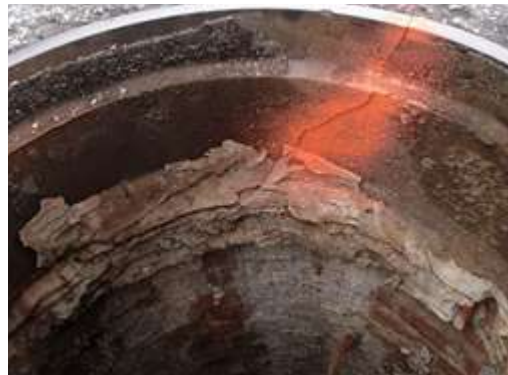
Defect

Frame leaks. Cracked frame. Adjustment infiltration.

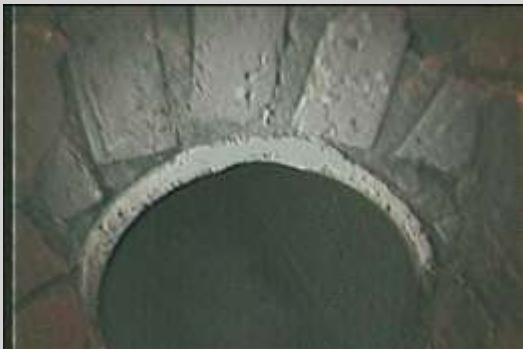
### 8 in. Circular Gravity Sewer Pipe In @ 3 O'Clock

Deposits: ☐ None ☒ **Mud** ☐ Sludge ☒ **Debris** ☐ Grease

Silt Depth: **1** (in.) Deposits Extent: **Light**

Infiltration: **None** Pipe Seal Cond: **Cracked**

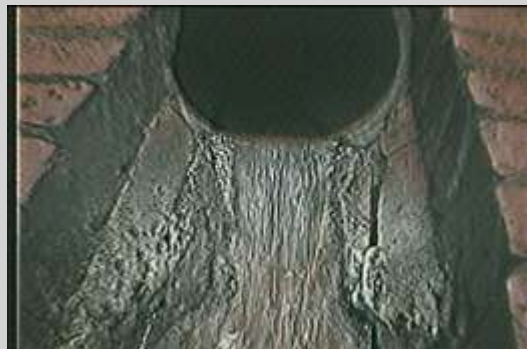
Pipe In @ 6 O'Clock

Channel deterioration.
